TECHNICAL REPORT HL-83-12

# BARKLEY DAM SPILLWAY TAINTER GATE AND EMERGENCY BULKHEADS CUMBERLAND RIVER, KENTUCKY

## Hydraulic Model Investigation

August 1983

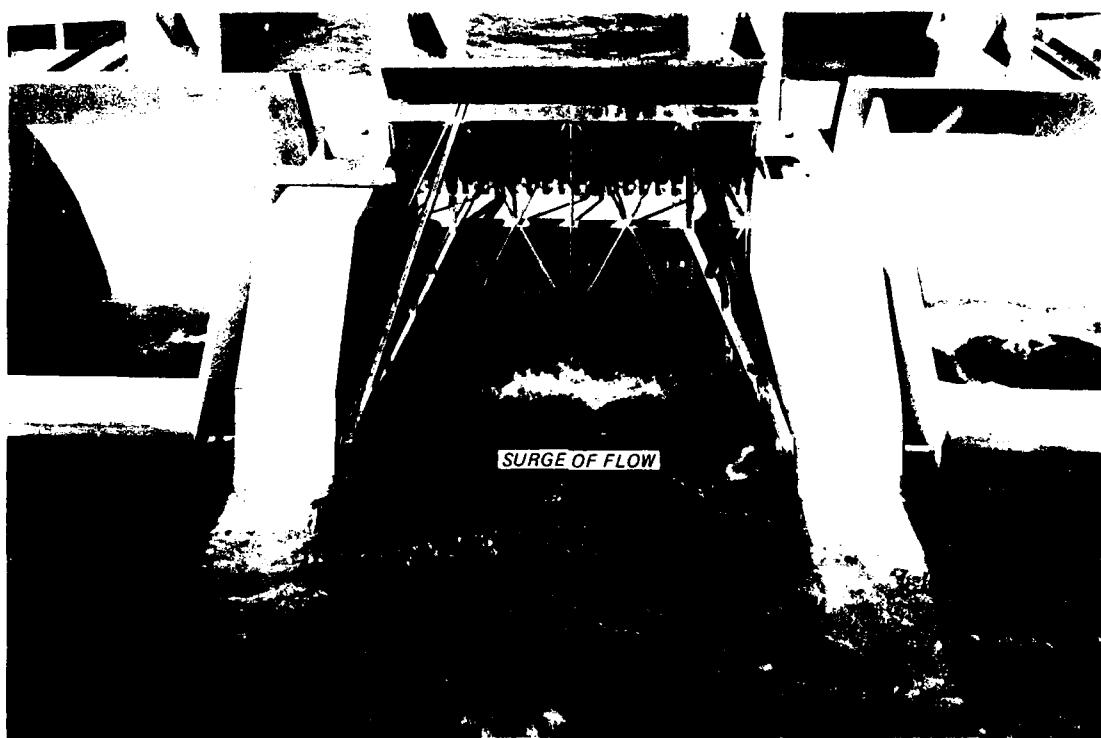
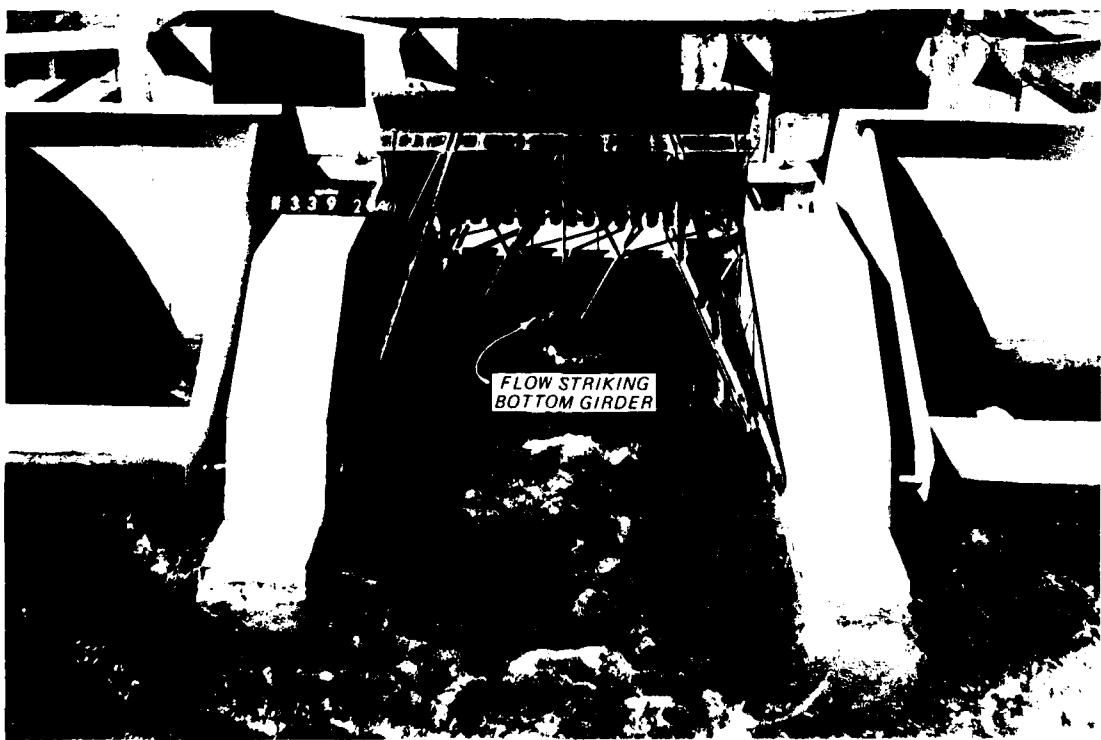
45. The tainter gate bouncing observed under certain flow conditions at the Barkley Dam project is caused by flow oscillation action which has been noted in previous model studies.\* This oscillation action occurs when water-surface differential between pool and tailwater is relatively small and flow is controlled primarily by tailwater. The presence of the tainter gate induces an unstable condition resulting in a periodic oscillation of the water surface in both approach and exit areas. Under the flow conditions experienced at the Barkley project, this oscillation is quite severe and results in a shift of flow control from a submerged controlled flow condition where the gates are partially open and the upper pool is controlled by both the submergence effect of the tailwater and the gate opening, to a free controlled flow condition where the gates are partially open and the particular gate opening controls the upper pool. The submerged controlled flow condition is predominant, but once the free controlled flow condition occurs, the oscillation begins and the associated surges of flow which move back into the gate bay and strike the bottom girder are strong enough to lift the tainter gate causing the bouncing phenomenon. This causes a large fluctuation of the load in the hoisting cables and mechanism.

a. Surge of flow underneath tainter gate

b. Flow striking bottom girder of tainter gate

Photo 1. Original design tainter gate; pool el 358.0,  
tailwater el 349.0, gate opening 20 ft

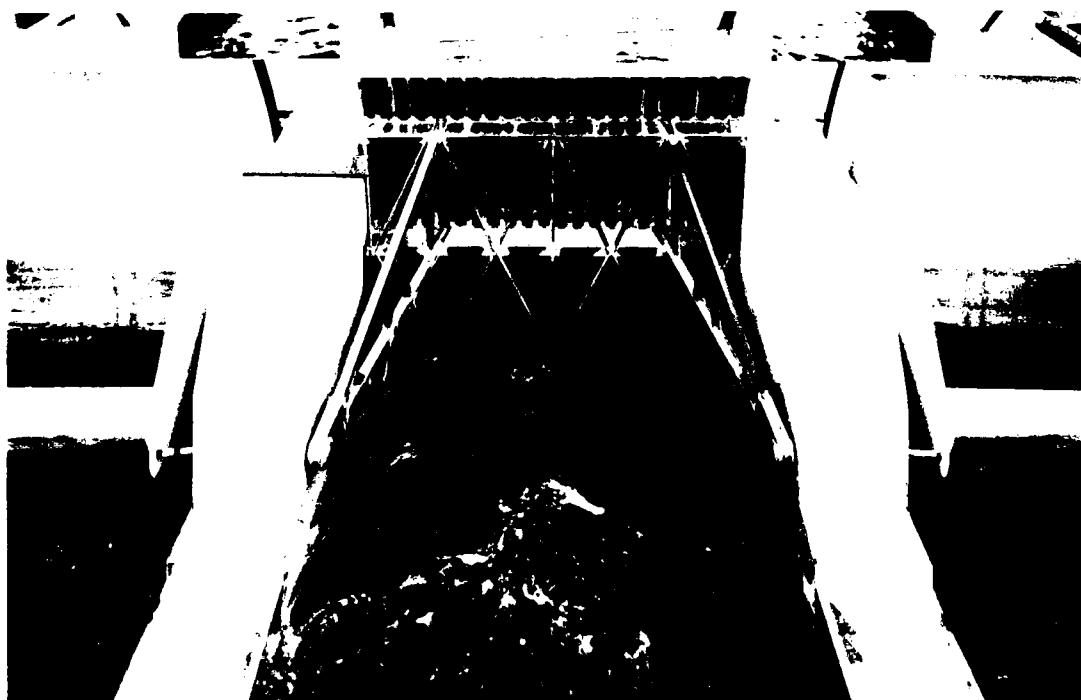
a. Original design

b. Type 9 design piers

Photo 4. Flow conditions; pool el 358.0, tailwater el 343.0,  
gate opening 12 ft

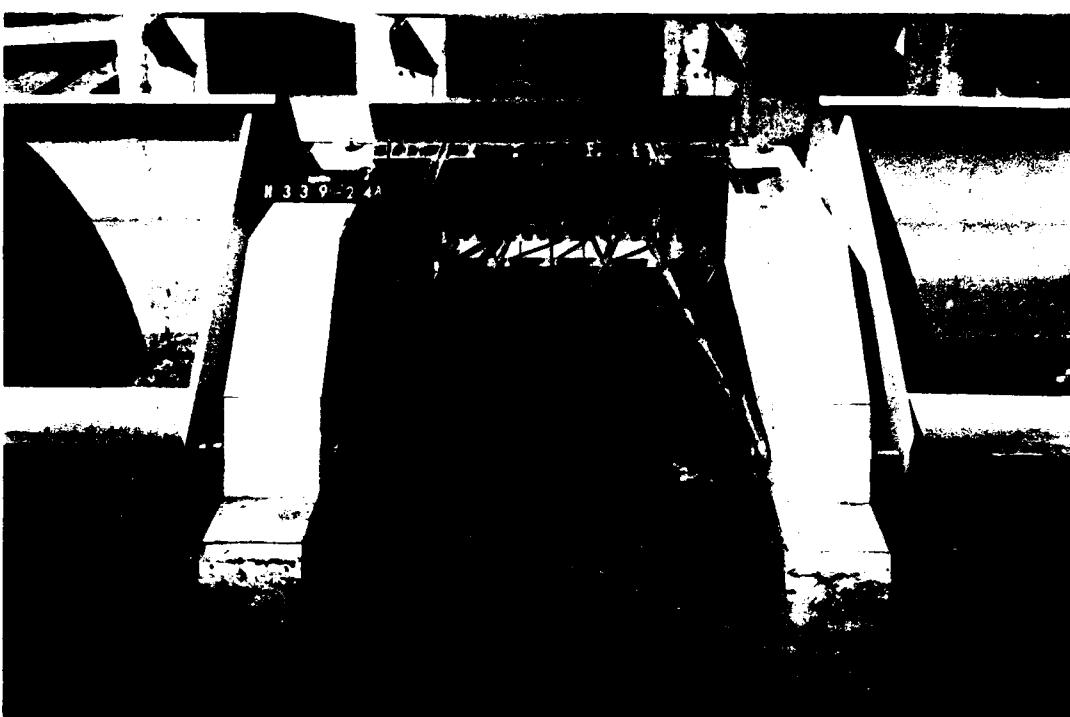
a. Original design

b. Type 9 design piers

Photo 5. Flow conditions; pool el 358.0, tailwater el 344.0,  
gate opening 14 ft
